Dalgety Bay Sailing Club Raft Stability Test.

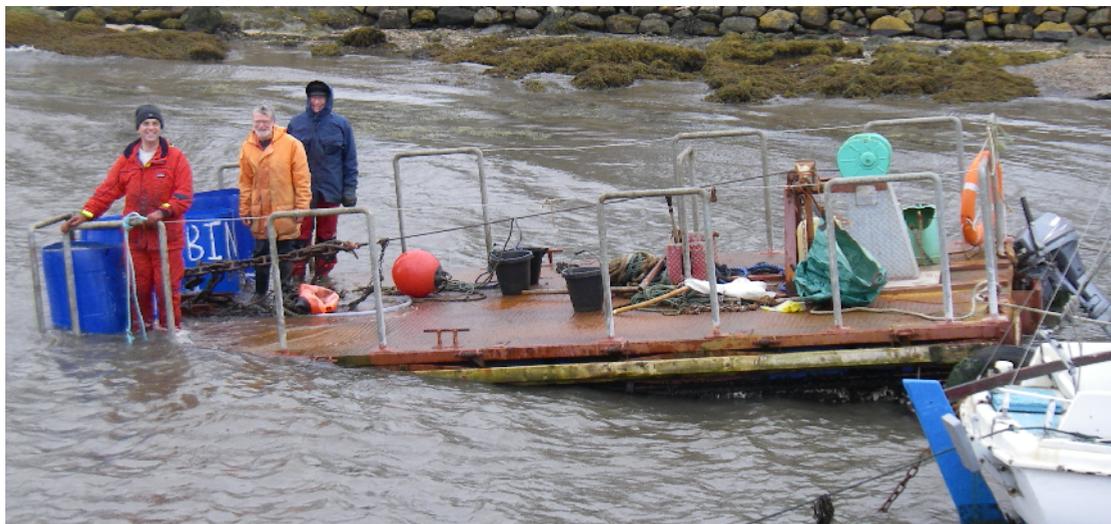
Further weight was added to the bows by filling four barrels with seawater. It is estimated that this increased the total bow loading to circa 2.5te. The tilt on the raft was now such that the water reached the handrail stanchion circa 1 metre from the bows. The raft was demonstrably still stable even when the 3 persons on board added their weight to the bows as shown in the following photograph.

There is ample warning of the load increasing toward the recommended safe limit due to the water level advancing from the bows. It is considered unlikely that anyone would continue to try and lift a weight greater than 2.5te with such obvious flooding of the bows.

It is concluded therefore that the raft is stable, with a suitable margin of safety, at the maximum safe working load of the winch (1.7te) even allowing for some swell. The raft should not be used in any case if there is a significant sea running as this risks unnecessary wear and tear on the structure.

Should multiple weights need to be lifted as described in the guidance, then lifting should cease before the water level at the bows reaches the second handrail stanchion. Further stability can be gained by filling the stern barrels which are secured at the aft end of the raft and thus counterbalance part of the raised load to reduce flooding at the bows. It is good practice to keep these barrels two thirds full at all times.
